## Old Schoolhouses of Leitrim Border Region

**Enda O'Flaherty** (introduction by Myra Reynolds)

# North West Leitrim National Schools

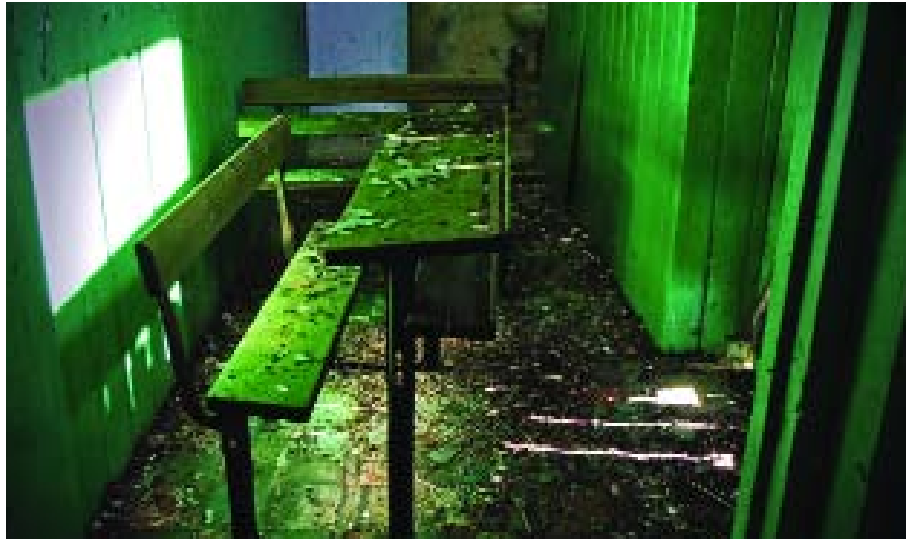
■ Gortahoose NS 1890 interior

The building comprises a detached four-bay single-storey former national school, built in 1890. It has a pitched slate roof with a red brick chimneystack, cast-iron rainwater goods and timber bracketed eaves. The external walls are pebble-dashed with a date plaque to the front elevation. Most of the glazing in the timber sash windows is broken and scattered inside.

This school house still stands today. Though derelict and beginning to collapse, inside, it is in good condition, and the echoes of past schooling can almost be heard amongst the scattered school furniture. In bright daylight, the school rooms seem vibrant still.

This national school building type is found throughout County Leitrim. Some of the schools are still in use in a highly-altered form but this example retains its original plan and features.

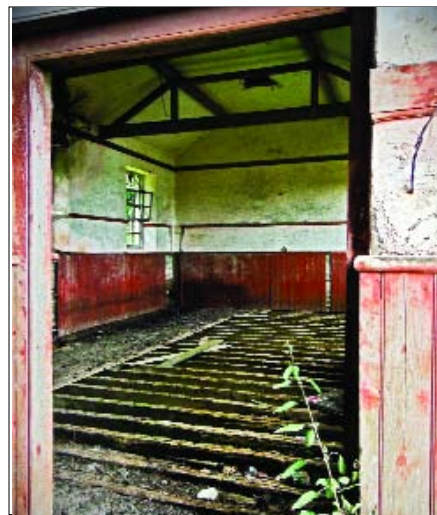
It was just a little over 100 years ago that a small one-roomed school house was built here overlooking the lakeshore. It is located on the northern side of the modern R199 road. The school building comprises a detached, single-storey, three-bay, one-roomed school house of rubble and brick construction, with a pitched slate roof. The date plaque indicates that it was constructed in 1887. It is near identical in form to the example from Sonnagh Old in Co Galway, and in a similar state of decay.

■ Drumreilly NS interior

Although now derelict, this former school building retains much of its early character and form. Its simple symmetrical form is typical of the standard school buildings designed and built in great numbers by the Office of Public Works for the Board of Education during the late 19th-century, and in the first decades of independence, particularly from c.1925 to c.1939. This particular school was built in 1887. Its form suggests that it was originally built as a one classroom school

although this impression is undermined by the boundary wall to the rear, which divides the yard into two separate enclosed spaces. The school retains many original features that enhance the facade such as the slate roof, timber sash windows and the carved limestone with incised Gaelic script. This simple school building was of social importance to the local community and represents a modest addition to the built heritage of the local area.

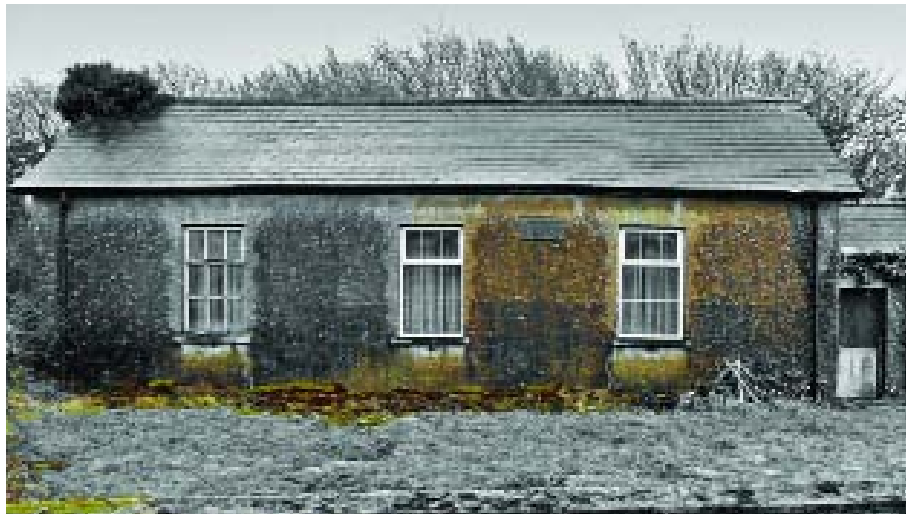
The school house comprises a detached single-storey one room building with a lower projecting pitched-roof gable porch, and a rear extension with a lean-to roof. It has a pitched roof and the walls are rendered and scored to imitate cut-stone blocks. It was con-

■ Carrigeencor NS 1872

structed in 1872. There is a low coarsely built rubble and mortar wall to the front with a wrought-iron gate. To the rear is the former toilet block. It is a simple stone and mortar construction with brick lintels over the doorways and a sheet-metal roof that has managed to stand the test of time.

This simple school house is a modest and functional building. The imitation cut-stone gives the building a pseudo-Victorian appearance despite its simple construction. Although it is not particularly striking from an architectural perspective, it stands as a testament to the scale of rural depopulation in the locality.

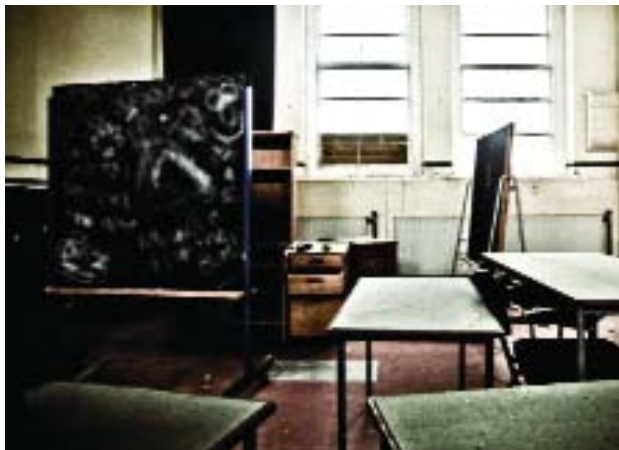
■ Tullaghan NS mid-20th cent

I passed this disused National School just outside the seaside town of Bundoran in Co Donegal early one Monday morning. It is situated just off the N15 on the Sligo side of the town. It had no name plate or date that I could see, though it appears to be a recently abandoned mid-20th century school house.
